Property Inspection Information

01/01/2016
Multi Unit
4 Unit, Reliance, LA 11111
(800) 338-7717

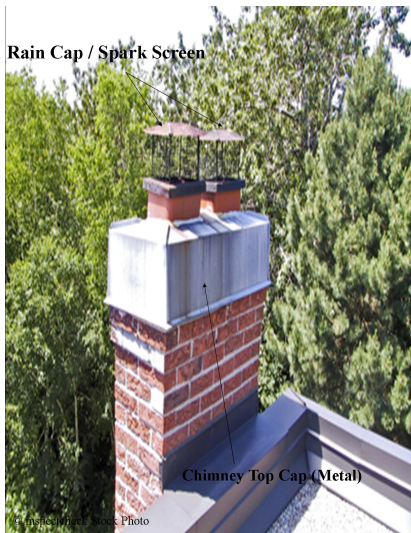
RECOMMEND INSTALLING A RAIN CAP / SPARK SCREEN

Installing a cap and screen at the top of the chimney will help prevent water from entering the flue. The screen will extinguish small sparks and prevent birds from making a nest.

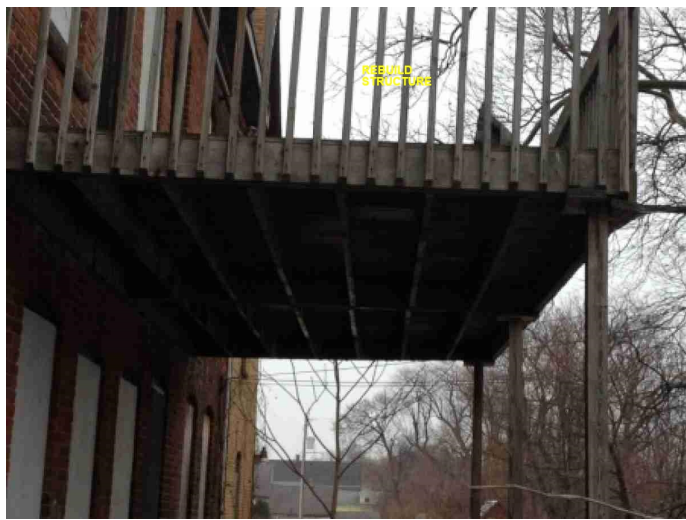
REBUILD / REPLACE

The structure / patio should be rebuilt and or replaced. It is not safe in its current condition. UNIT 3-4

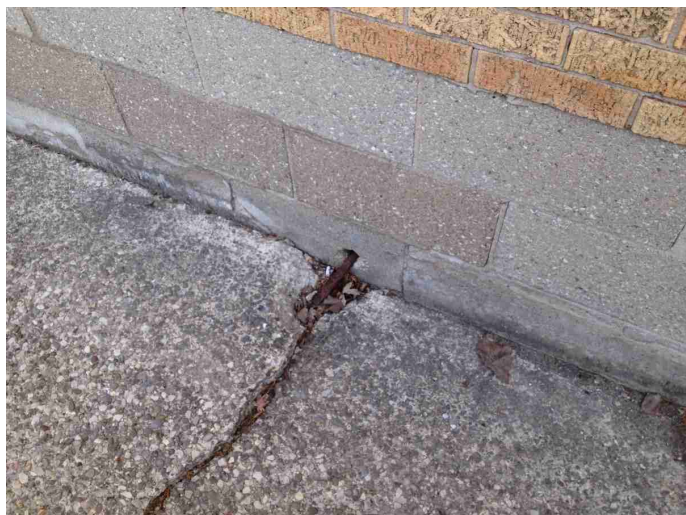
HEAVING / SETTLING

Heaving means the concrete or asphalt has lifted or settled. The concrete or asphalt will probably have to be replaced. - UNIT 1

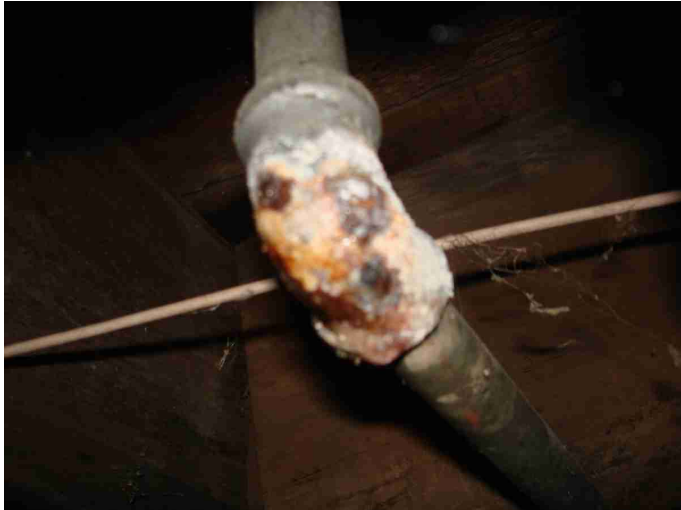
CONSIDERABLE DAMAGE / CORROSION / UNSATISFACTORY CONNECTIONS NOTED

These areas should be closely monitored for leaks. They will have to be replaced in the near future. Recommend replacing any deteriorated pipes with copper or other approved pipe. Noted to many areas of galvanized pipe.

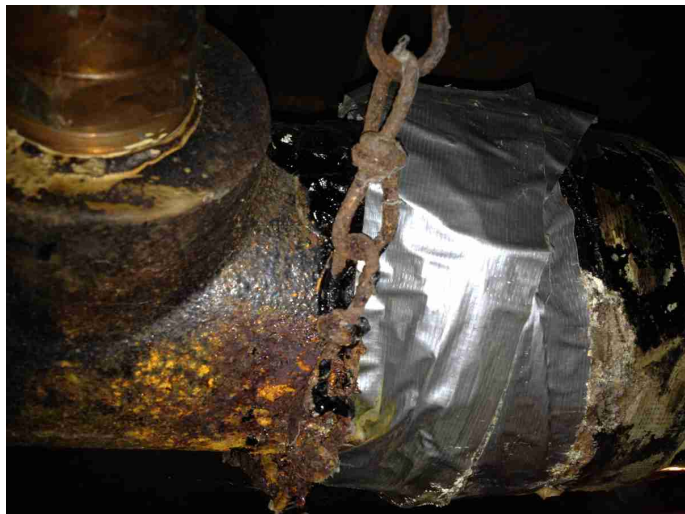
CONSIDERABLE CORROSION / DAMAGE

These areas should be closely monitored for leaks and repaired / replaced as necessary with approved pipe by a licensed plumber.

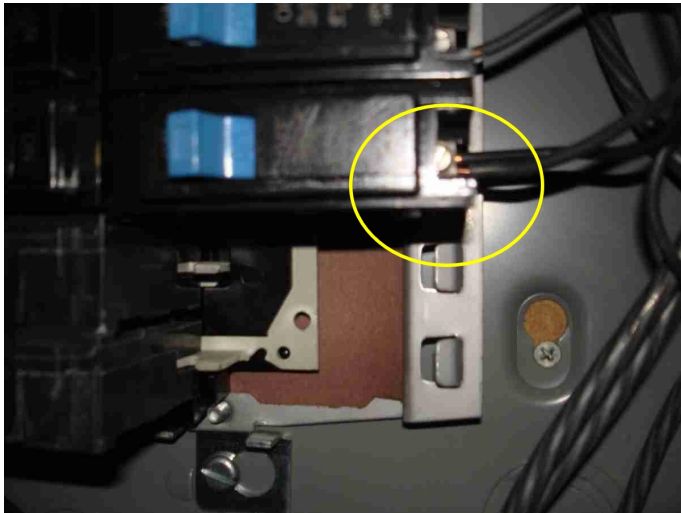
MULTIPLE LUGGING / TAPPING NOTED

When more than one branch circuit conductor (hot / neutral / ground) is connected to a circuit breaker, fuse lug, neutral or ground bus the condition is known as multiple lugging or multiple tapping. This can be alleviated by adding additional circuit breakers / fuses or busses (neutral or ground). Recommend repair by a licensed electrician. Noted to Main Service Panel 3

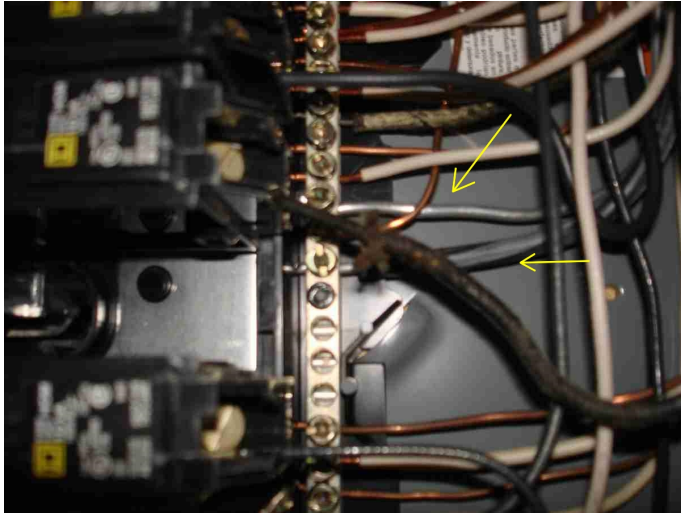
Aluminum branch circuits can be potentially dangerous if proper connections and materials are not used. Improperly connected and sized aluminum wiring has resulted in fires. Any aluminum branch circuit wiring smaller than #6 AWG solid conductor, or #8 AWG stranded conductor should be replaced or updated with COPALUM Crimp Connectors. (See U.S. CPSC Publication 516). Evaluation of these branch circuits and components should be performed by a licensed electrician AS SOON AS POSSIBLE. - NOTED TO MAIN

SERVICE PANEL 3
